PROSPECT MINI HYDRO: REMEDIATION THROUGH STAKEHOLDER ENGAGEMENT AND ROOT CAUSE ANALYSIS

Michael Martin, Koen Windey
Stark Engineering Consulting, Sydney, NSW, Australia

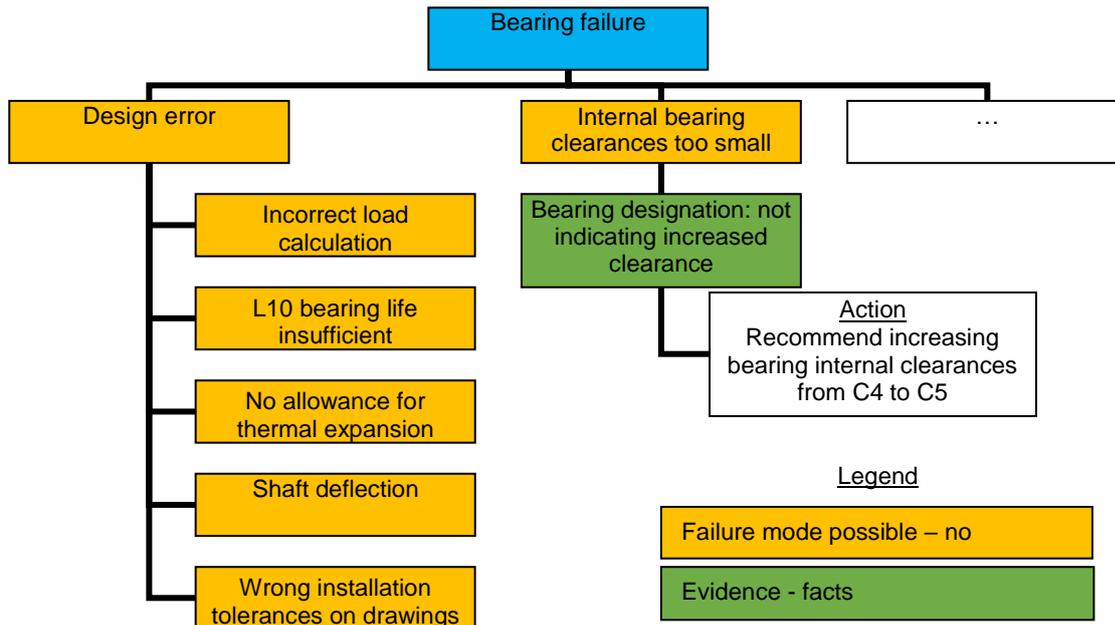
3. Two external consultants were engaged to produce a desktop root cause review of the primary symptoms. An OEM-independent review ensured industry best-practice and un-biased conclusions. Figure 2 illustrates part of the identified fault tree presented in the desktop review.

Figure 2: Part of root cause analysis tree

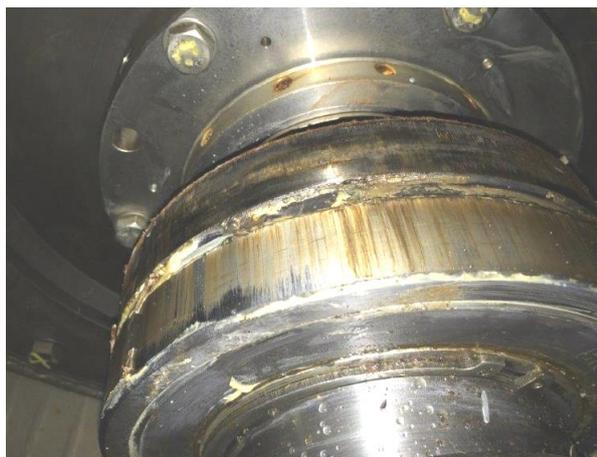
- a. Seizing of the non-drive end bearing outer race inside its housing results in loss of axial float and consequential axial overload, see Figure 3. The exact mechanism of the seizing of the bearing was found difficult to be established with certainty. Nonetheless, aggravating factors such as water ingress into the bearing housing and possibly bearing, surface corrosion of the mild steel bearing housing, insufficient internal bearing clearance and axial shaft movement during start-up and shut-down were believed to be factors that needed addressing.

Figure 3: Non-drive end bearing failure, showing seizure and water ingress

- i. Re-design of the non-drive end bearing arrangement to address the most likely root cause of excess axial loads, with a minimal modification to the original design

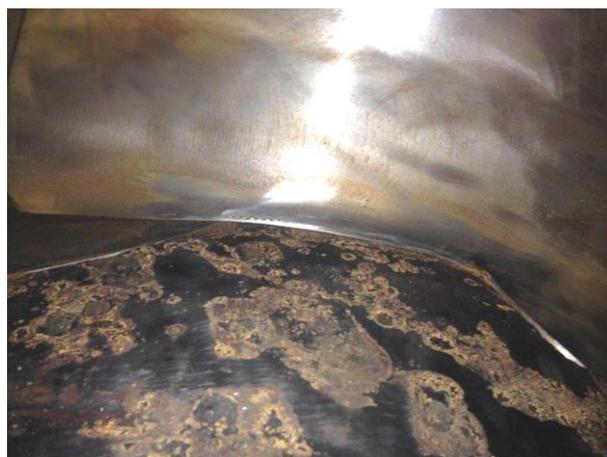
- c. Use of electroless nickel plating on the non-stainless steel turbine components was found to be unconventional. Minor scratches or defects in the coating are believed to lead to localised galvanic cells which result in the observed severe pitting of the underlying structure, see Figure 4.

Figure 4: Kaplan hub showing failure of nickel plating and pitting corrosion

- ii. Re-design of the mechanical seal flushing mechanism to eliminate contamination with silt and corrosion deposits
 - iii. In-situ treatment of corrosion with a suitable corrosion inhibitor and primer

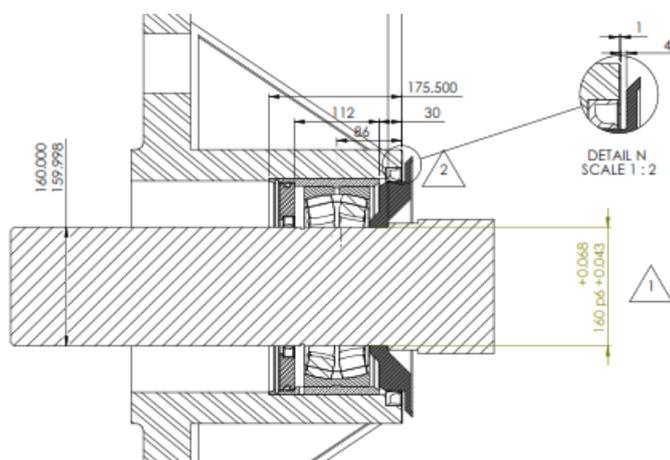
1. In-house design modification of the non-drive end bearing arrangement. In the absence of OEM-provided manufacturing drawings, in-situ measurements were relied on. An aluminium bronze sleeve installed in a modified bearing housing carried a higher C3 clearance, open bearing, with externally lubricated H1 food grade grease. The design caters for bearing cavity seals on each side, including a stainless steel 'flinger' to prevent water ingress from the nearby mechanical seal. The assembly is replaceable in-situ. External greasing of the new bearing is performed using an automatic grease pack and an externally accessible grease line, see *Figure 5*.

Figure 5: Redesigned bearing housing to prevent water ingress, provide external greasing and ensure axial float
