PROSPECT MINI HYDRO: REMEDIATION THROUGH STAKEHOLDER ENGAGEMENT AND ROOT CAUSE ANALYSIS

Michael Martin, Koen Windey
Stark Engineering Consulting, Sydney, NSW, Australia

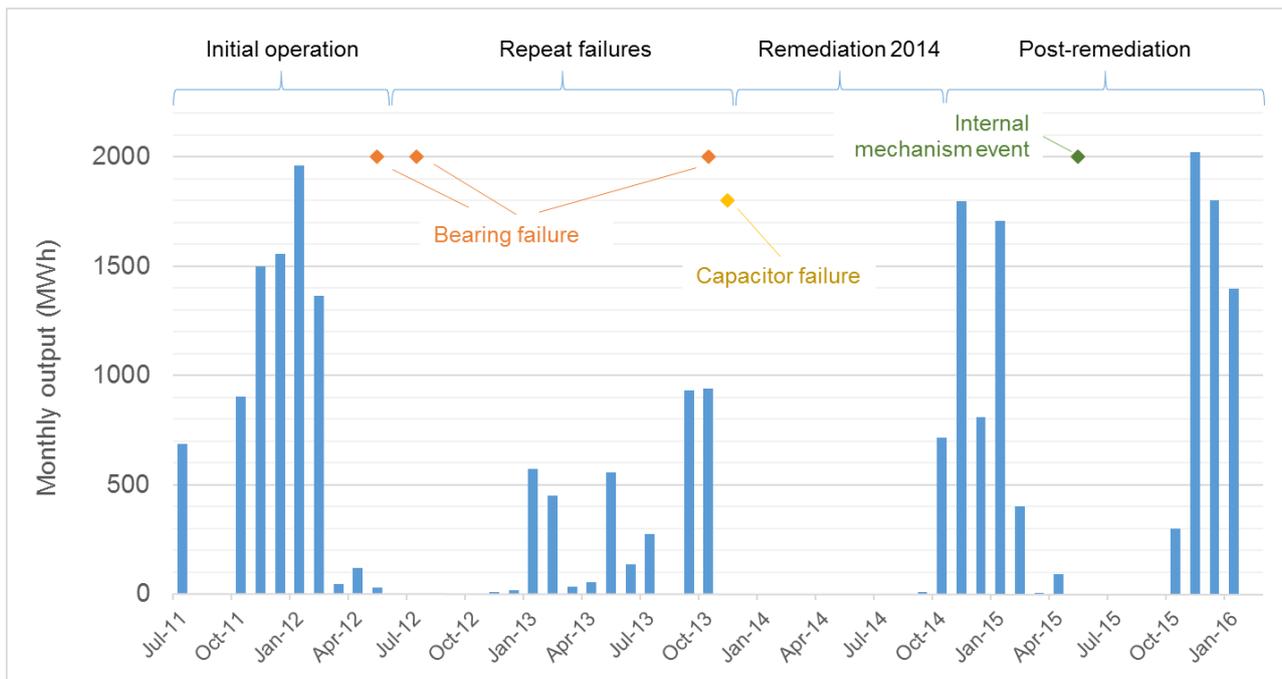
Figure 1: Mini hydro monthly performance since commissioning

In July 2012, after less than 0.9 GWh of generation, the same bearing failed again. Once again, an identical bearing was installed. This time, by recommendation of SKF, an anti-fretting paste was applied to the bearing housing to facilitate the required sliding fit. Refer Figure 1.

In November 2013, a third bearing failure occurred, shortly followed by an identified defect on a high voltage capacitor. The hydro was left disabled, pending further investigation.

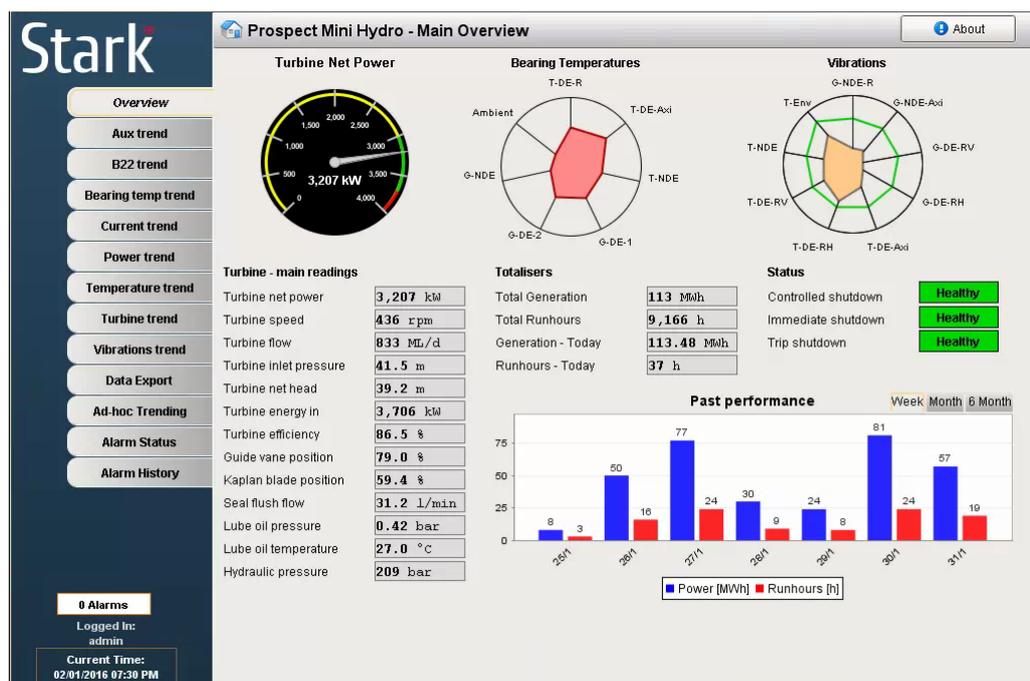
Figure 6: Remote access dashboard and datalogger

2. Upgrading of the vibration monitoring system to include reliable full-spectrum vibration monitoring.
3. Installation of enhanced data logging and remote access dashboard, allowing for customisable trends and reporting. More and accurate data as well as the instant access to it has already proven to be a key in assisting operators with diagnostics and accurate reporting to stakeholders. Typical turn-around after a trip event is now typically 4-5 hours, compared to previously 2-3 days. This has been a vast improvement in communication with stakeholders. Refer Figure 6.
